⑥ National Dam Inspection Program
Zinc Dam. (NDI Number PA 43416)

~~ENGINEERING~~
WASHINGTON COUNTY, ~~COMMONWEALTH OF~~ PENNSYLVANIA.
~~NDI No. PA-99496~~
~~PennDER No. 635~~

PHASE I INSPECTION REPORT
NATIONAL DAM INSPECTION PROGRAM

Prepared by: MICHAEL BAKER, JR., INC.
Consulting Engineers
4301 Dutch Ridge Road
Beaver, Pennsylvania 15009

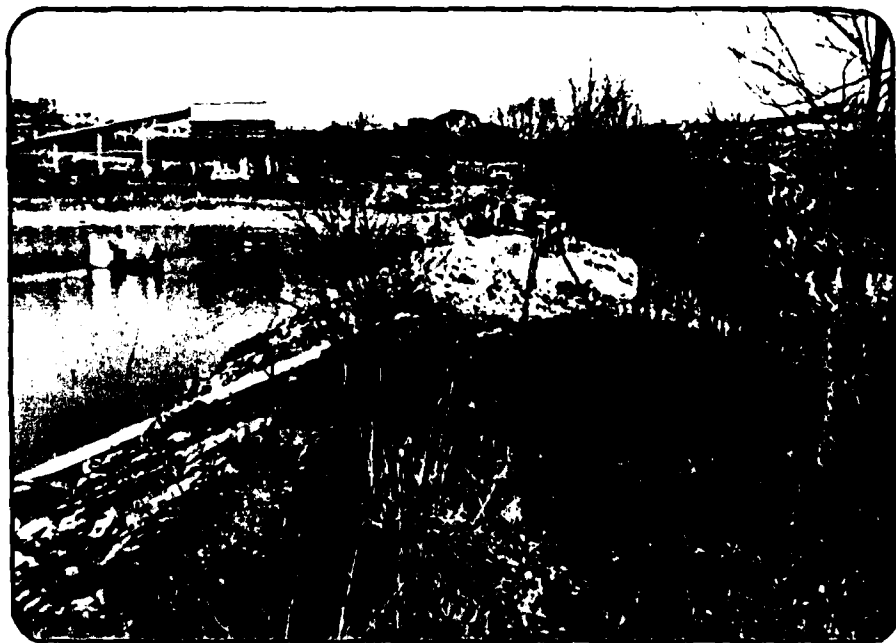
Overall View of Dam from Right Abutment

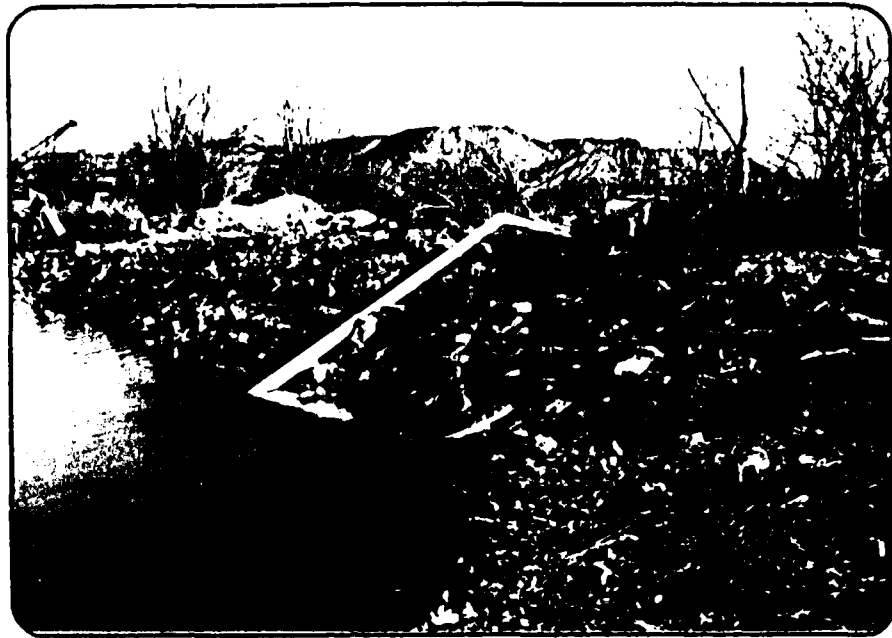
PHOTO 1. View of Entrance to Spillway

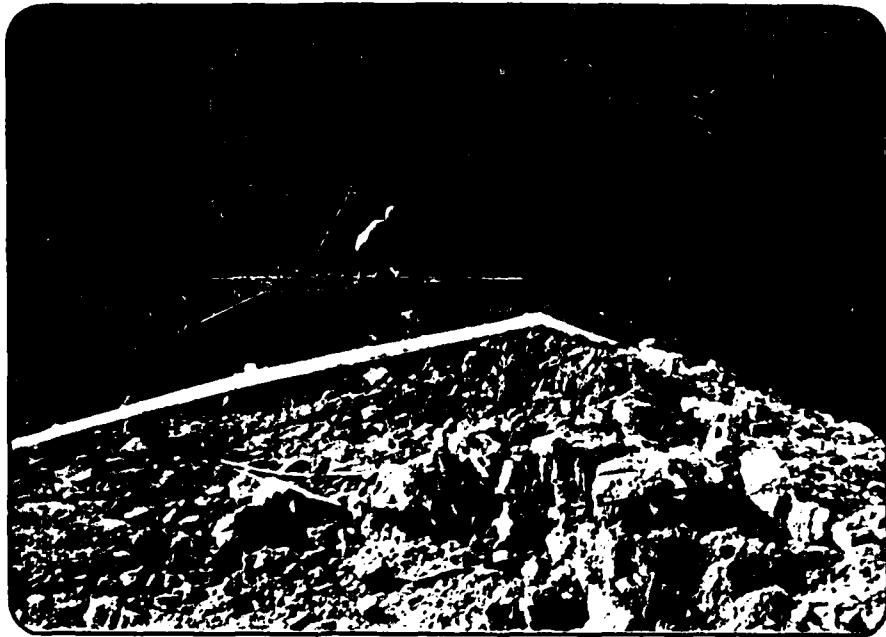
- c. Appurtenant Structures - The spillway structure is in very poor overall condition. The downstream half is undermined and deteriorated (see Photo 2). The crest elevation of the spillway was modified (raised) with a concrete block and mortar wall with earth piled on top. The freeboard was reduced to as low as 0.4 foot, while approximately one foot was the average (see Photos 3 and 5).

PHOTO 3. View Across Crest of Spillway

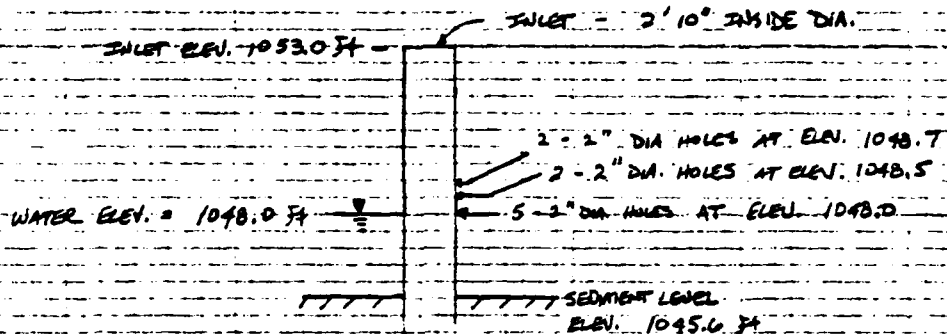
OUTLET WORKS LOCATED AT STATION 2+00

2" DIA. HOLES DRILLED INTO OUTLET PIPE DURING INSPECTION
ON 20 NOV. 1979
